Figure II-23
Alternative 2
Housekeeping Camp (Subarea 6)

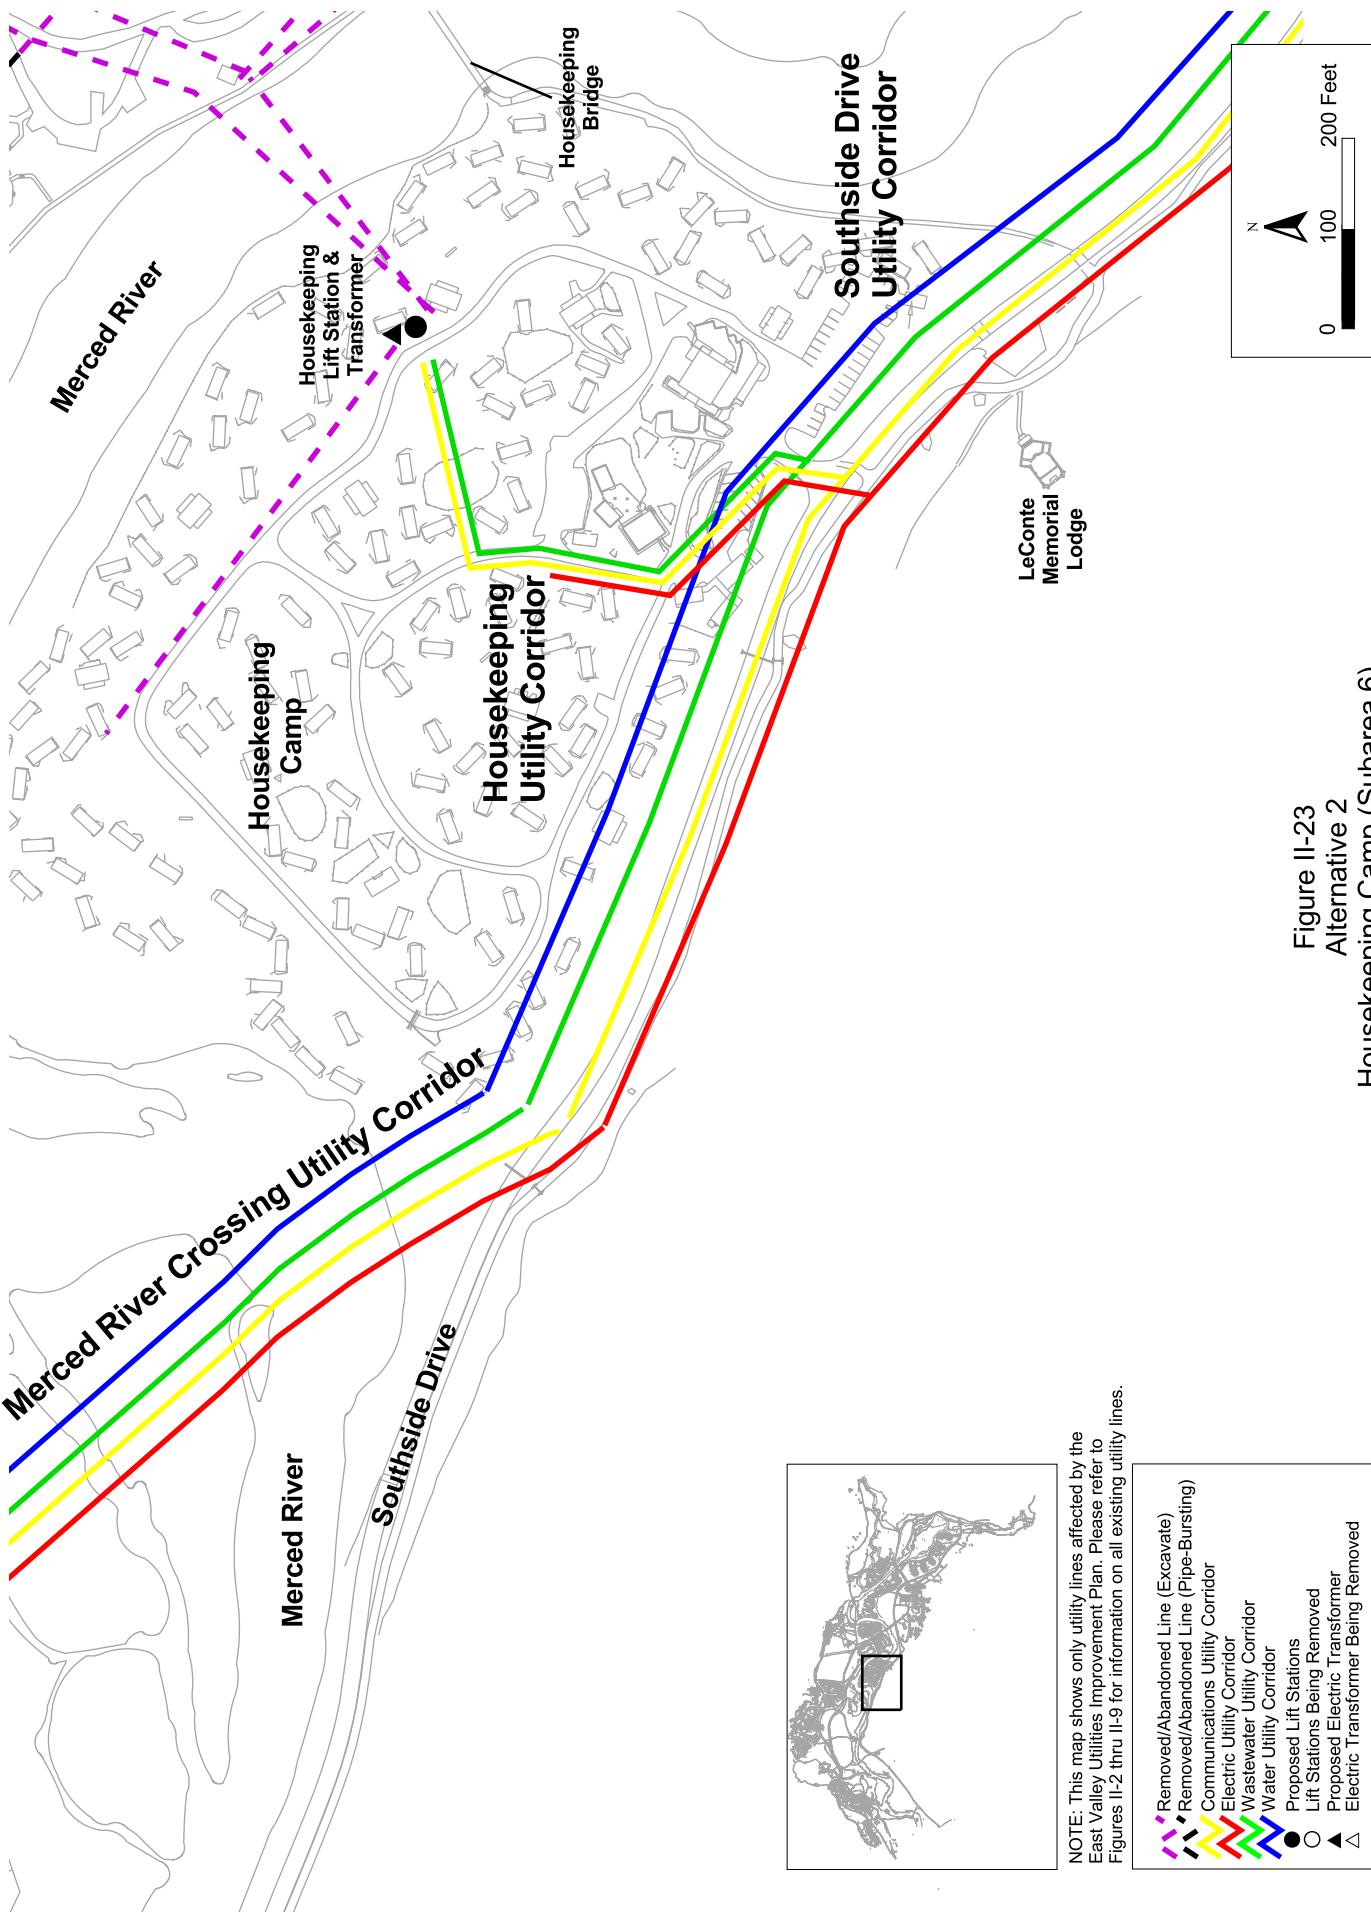
NOTE: This map shows only utility lines affected by the East Valley Utilities Improvement Plan. Please refer to Figures II-2 thru II-9 for information on all existing utility lines.

- Removed/Abandoned Line (Excavate) - represented by a pink dashed line
- Removed/Abandoned Line (Pipe-Bursting) - represented by a yellow dashed line
- Communications Utility Corridor - represented by a blue line
- Electric Utility Corridor - represented by a red line
- Wastewater Utility Corridor - represented by a green line
- Water Utility Corridor - represented by a purple line
- Proposed Lift Stations - represented by a grey circle
- Lift Stations Being Removed - represented by a black circle with a white center
- Proposed Electric Transformer - represented by a grey triangle
- Electric Transformer Being Removed - represented by a black triangle with a white center
